Technical Report M5

**SEDIMENTATION STUDY OF THE MISSISSIPPI RIVER  
SCHENIMANN CHUTE  
MISSISSIPPI RIVER MILES 63 TO 57  
HYDRAULIC MICRO MODEL INVESTIGATION**

By  
*David C. Gordon*  
*Robert D. Davinroy*

Final Report — May, 2000

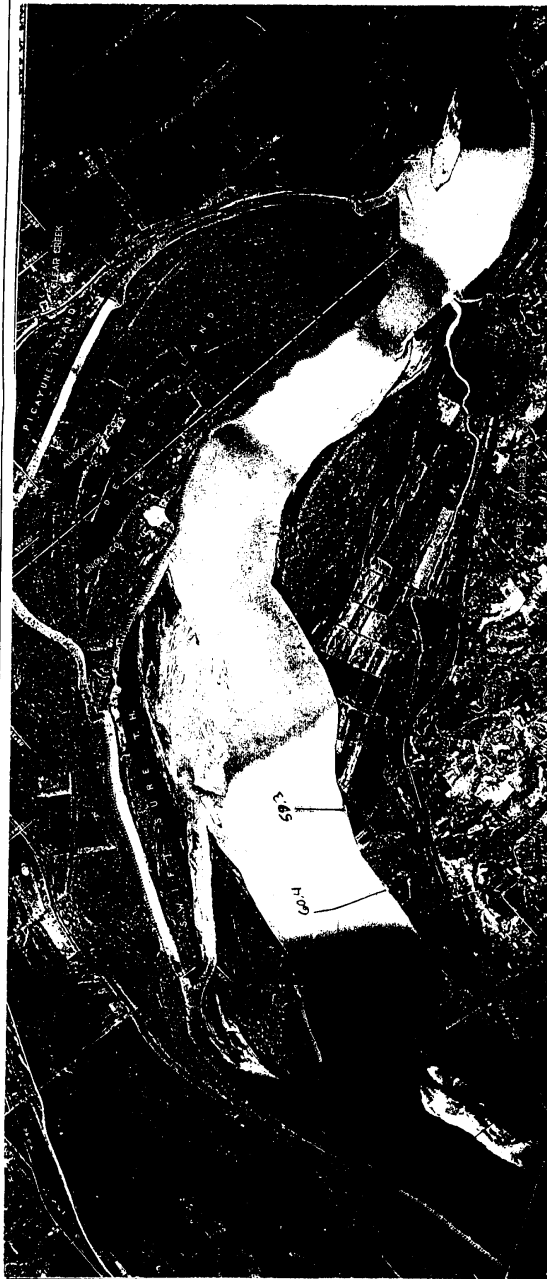
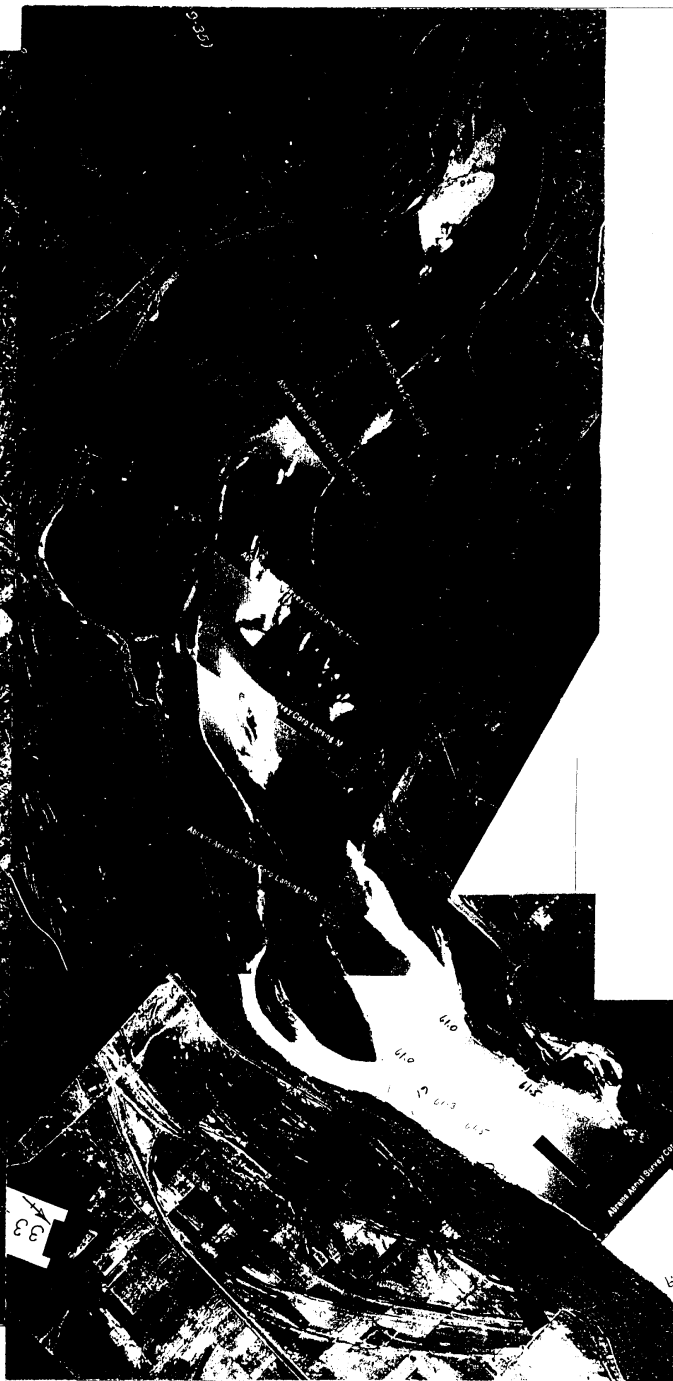
U.S. ARMY ENGINEER DISTRICT, ST. LOUIS CORPS OF ENGINEERS ST. LOUIS, MISSOURI
PREPARED BY: D. Gordon DRAWING BY: A. Rosen CHECKED BY: R. Denny	SCHENIMANN CHUTE MICRO MODEL STUDY MISSISSIPPI RIVER MILES 63 TO 57 1932 AND 1935 AERIAL PHOTOGRAPHS
PLATE NO.	5

Aerial photographs from 1932 and 1935 on Plate 5 show newly constructed river training structures on both the Missouri and Illinois banklines. In 1932, the initial stages of the side channel formation were just beginning in the upper reaches of Schenimann chute. The 1935 photograph shows a rapid development of the upper portion of the chute. Within a short 3-year time period a large portion of the upper side channel had been formed. By 1965 (Plate 6), Picayune Chute was fully developed while the lower reach of Schenimann Chute was still maturing. Plate 2 shows that each complex is now fully developed with one dominant side channel for each.

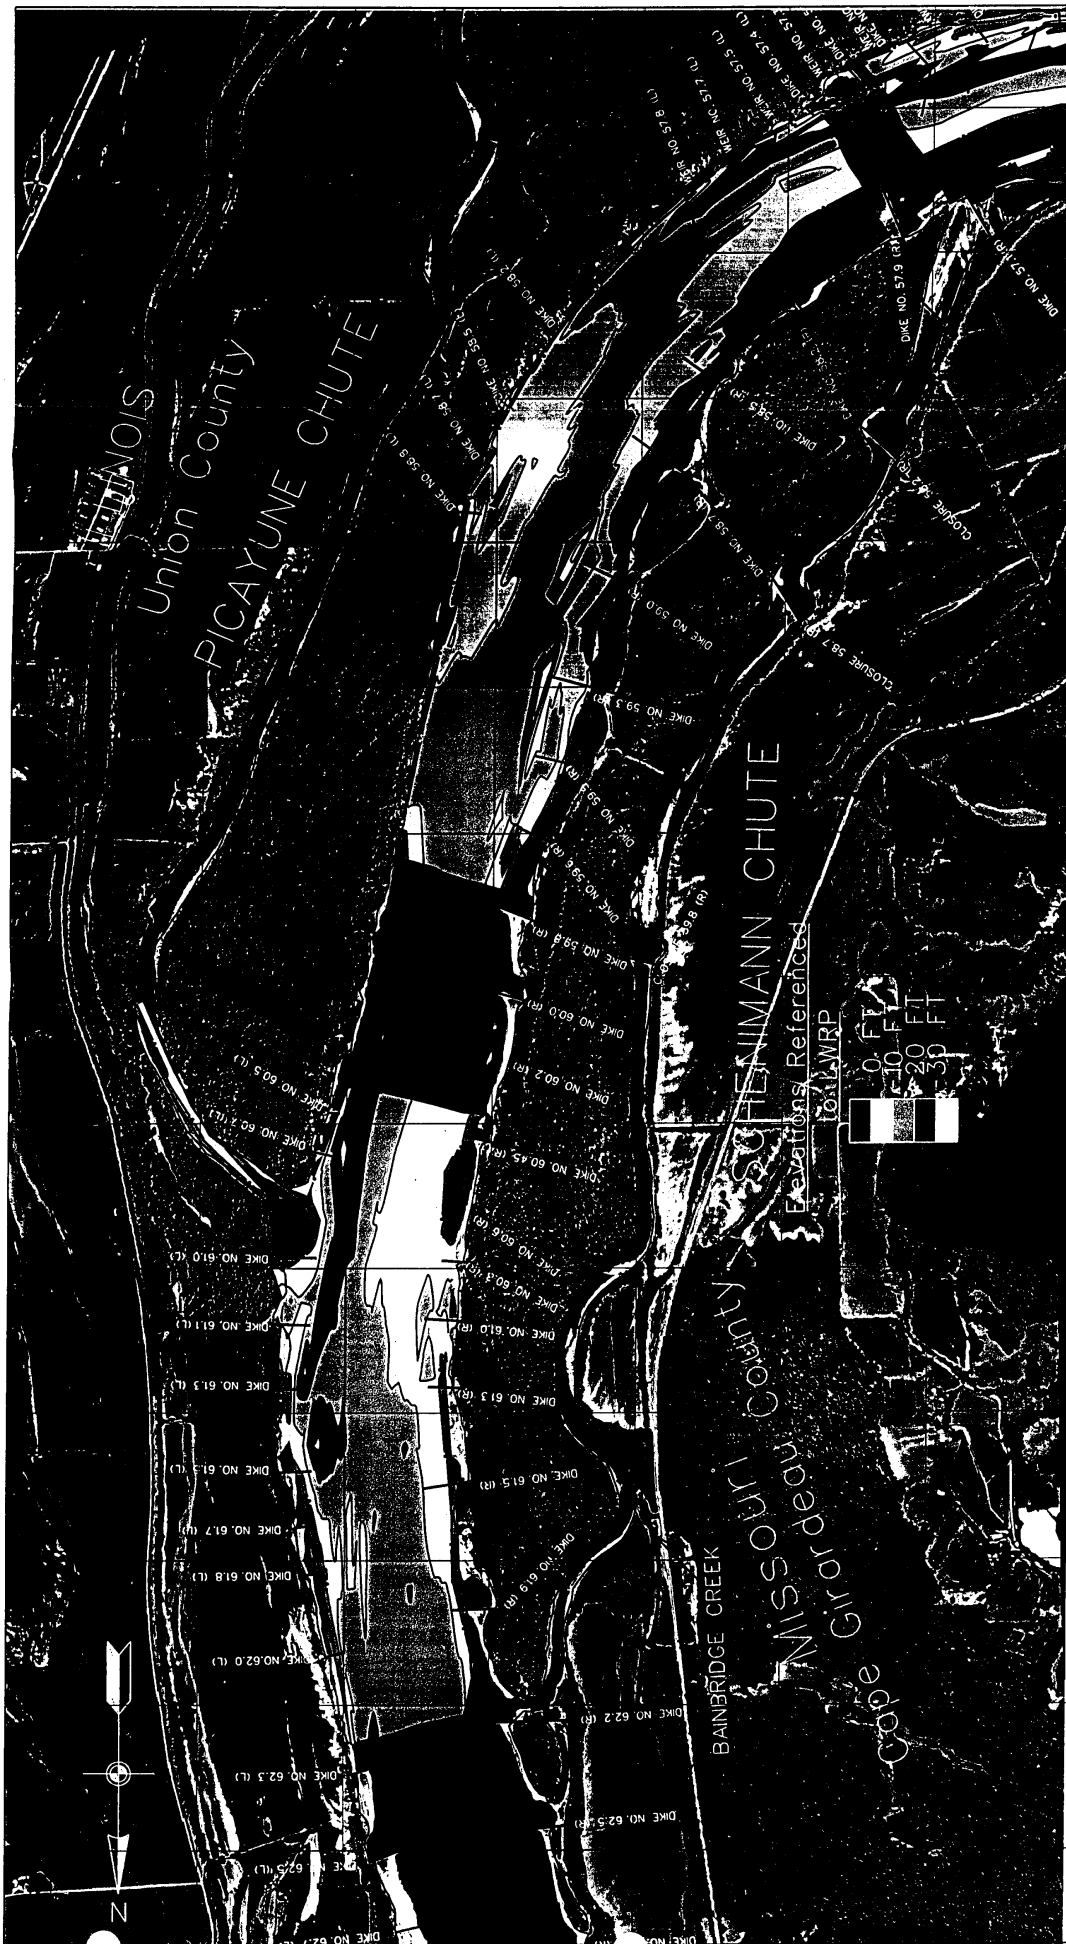
<p>U.S. ARMY ENGINEER DISTRICT ST. LOUIS CORPS OF ENGINEERS ST. LOUIS, MISSOURI</p>
<p>SCHENMANN CHUTE MICRO MODEL STUDY MISSISSIPPI RIVER MILES 63 TO 57 1989 PROTOTYPE SURVEY</p>	<p>1700 1275 850 425 0 850 1700</p>
<p>DESIGN FILE: 441000-1-1000 PLOT DATE: 5/00 PLATE NO.: 10</p>

Plates 10, 11 and 12 are plan view hydrographic survey maps of the Mississippi River from 1989, 1993, and 1995/96, respectively. Each survey shows that the channel thalweg was located along the right descending bank at the entrance to Schenimann Chute. Near Mile 61.5, a crossing existed with depths near -10 feet LWRP. Here the channel transitioned to the left descending bank just upstream of the entrance to Picayune Chute. The channel created a deep thalweg against

the bank and the dikes with depths near -30 feet LWRP. A long crossing then developed back to right descending bank between Miles 60.0 and 59.0. Depths in this area ranged between -10 and -20 feet LWRP. The channel then crossed back to the left descending bankline between Miles 59.0 and 58.0. Depths in this crossing were near -10 feet LWRP. The channel then remained on the outside of the bend throughout the remainder of the study reach.

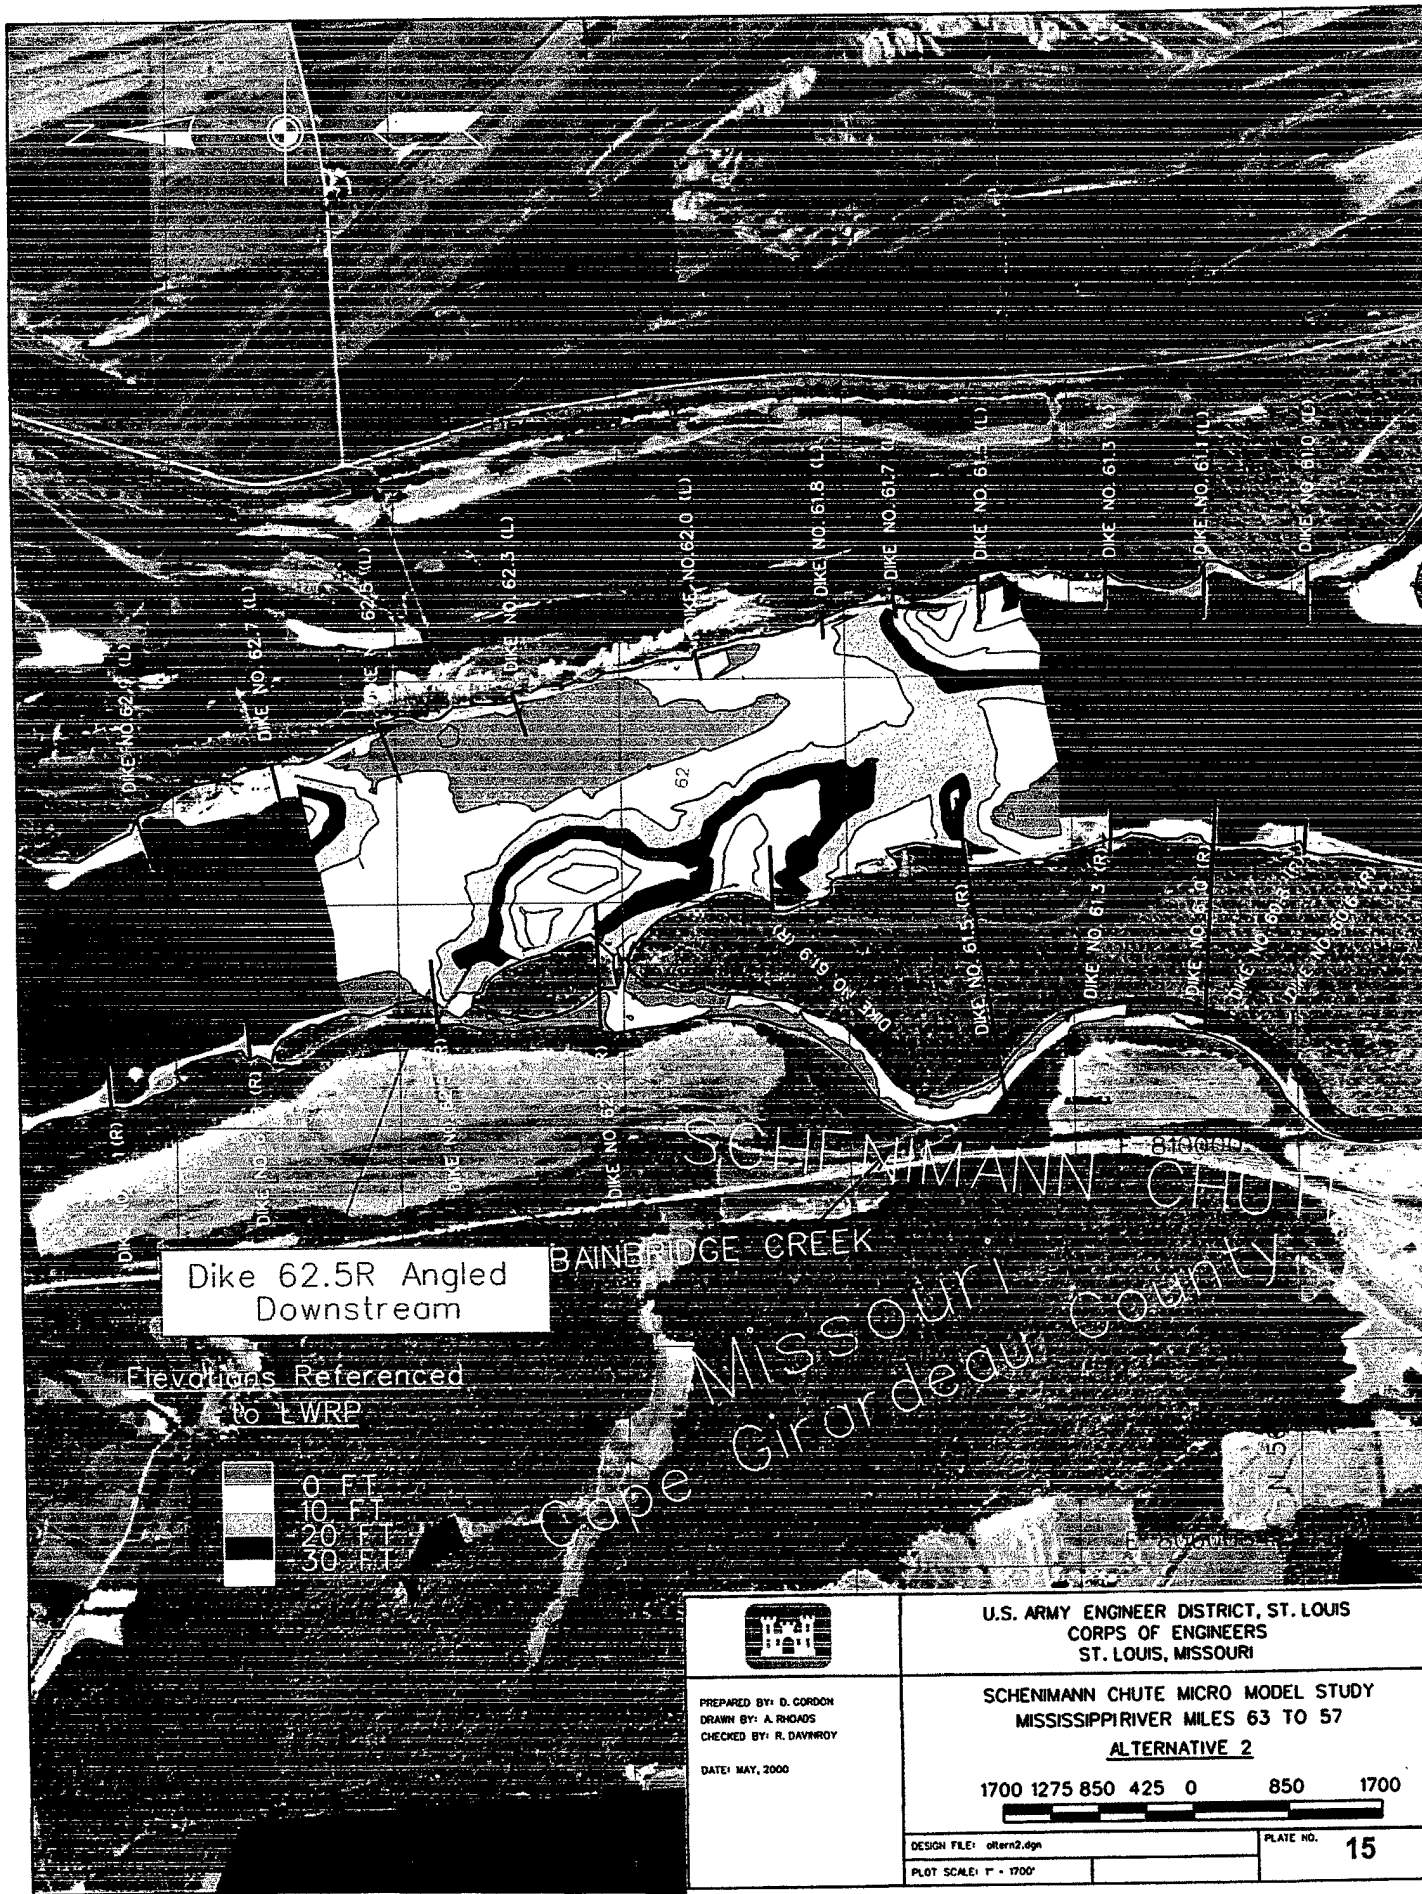
Plate 15 is a plan view contour map of the resultant bed configuration of Alternative 2. Results of this test indicated that angling Dike 62.5 downstream created shallower depths in the main channel upstream and downstream of the structure. The purpose of the design was to divert additional flow into Schenimann Chute when the dike was overtopped. However, the design did not impact the flow or bed response in the side channel.
